Maryland Inventory of Historic Properties number: BA-2789

Name: MD 151 over MD 150

MARYLAND INVENTORY OF HISTORIC BRIDGES
HISTORIC BRIDGE INVENTORY
MARYLAND STATE HIGHWAY ADMINISTRATION/
MARYLAND HISTORICAL TRUST

SHA Bridge No. 3098 Bridge name MD 151 over MD 150

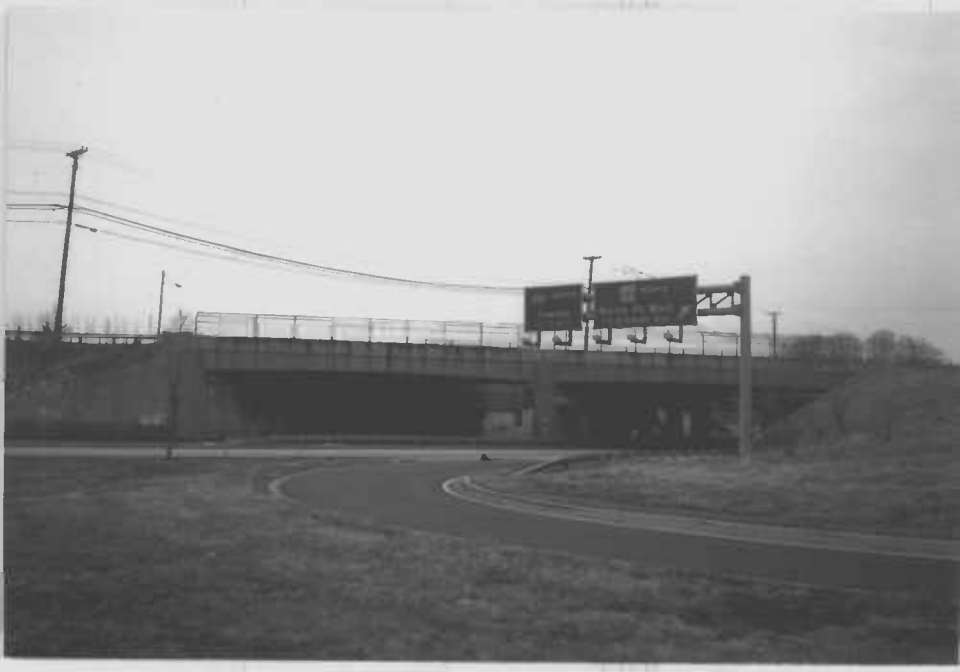
1. BA-2789
2. MD 151 over MD 150
3. Baltimore County
4. Eric Greffitts
5. 3/97
6. MD SHPO
7. south elevation
8. 1 of 6

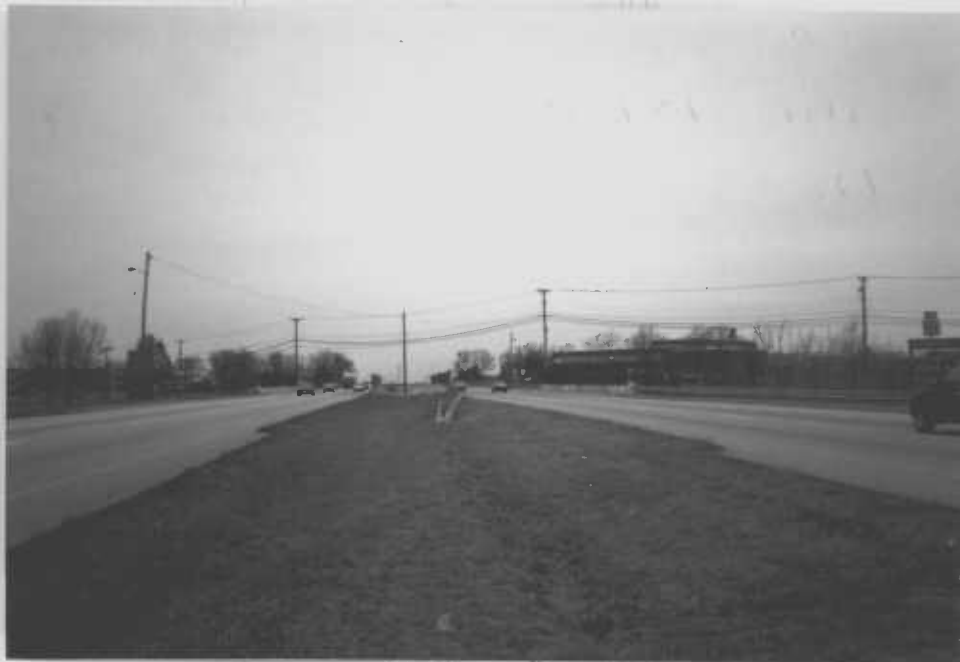
1. BA-2789
2. MD 151 over MD 150
3. Baltimore County
4. Eric Huffitts
5. 3/97
6. MD SHPO
7. west approach (MD 151)
8. 2 of 6

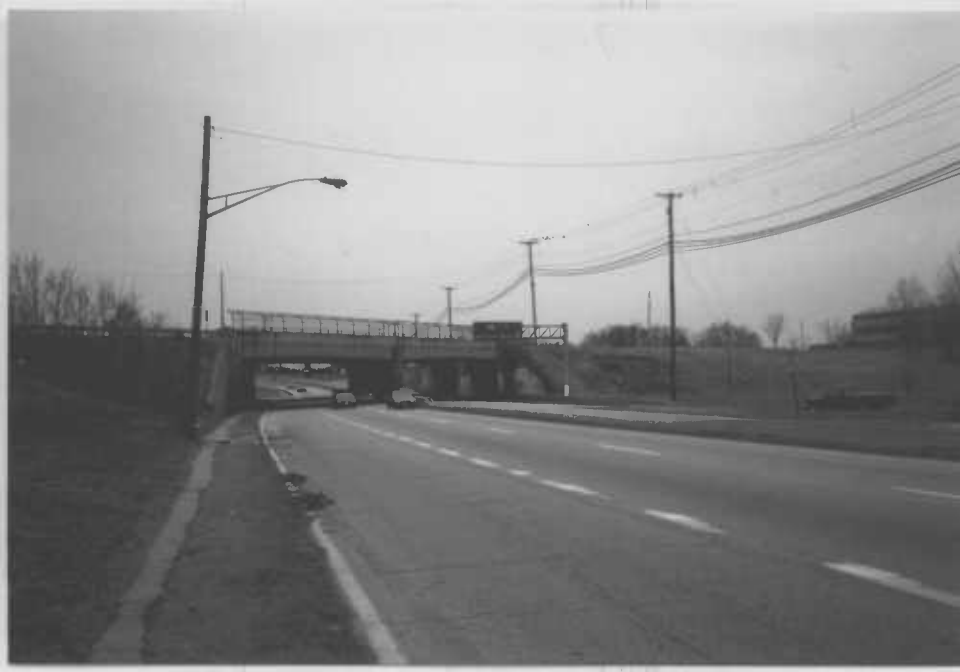
1. BA-2789
2. MD 151 over MD 150
3. Baltimore County
4. Eric Huffitts
5. 3/97
6. MD SHPO
7. north elevation
8. 3 of 6

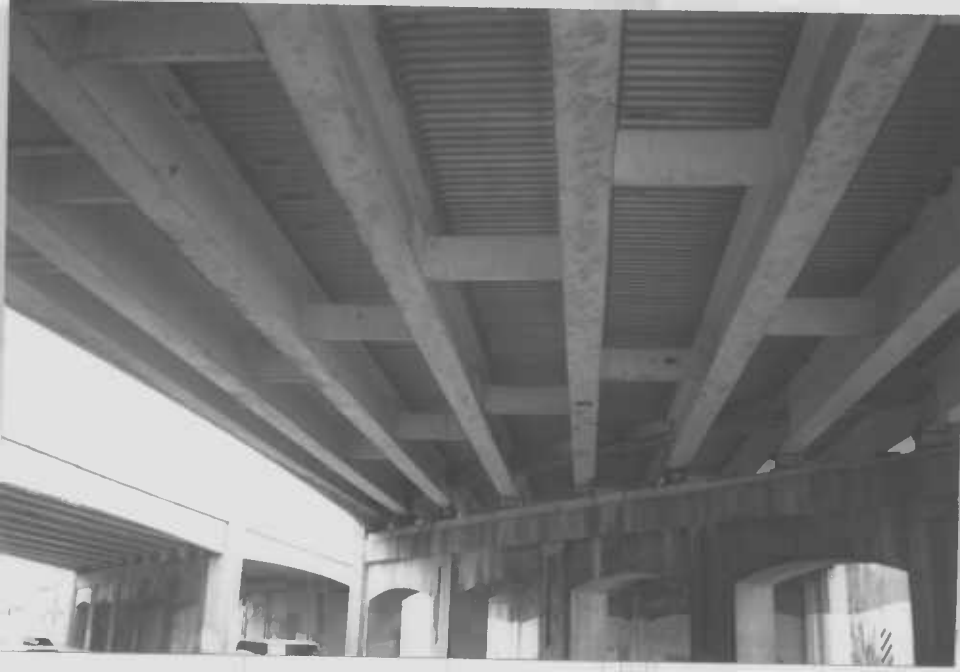
1. BA: 2789
2. MD 151 over MD 150
3. Baltimore County
4. Eric Driffitts
5. 3/97
6. MD SHPD
7. grider detail + pier
8. 4 of 6

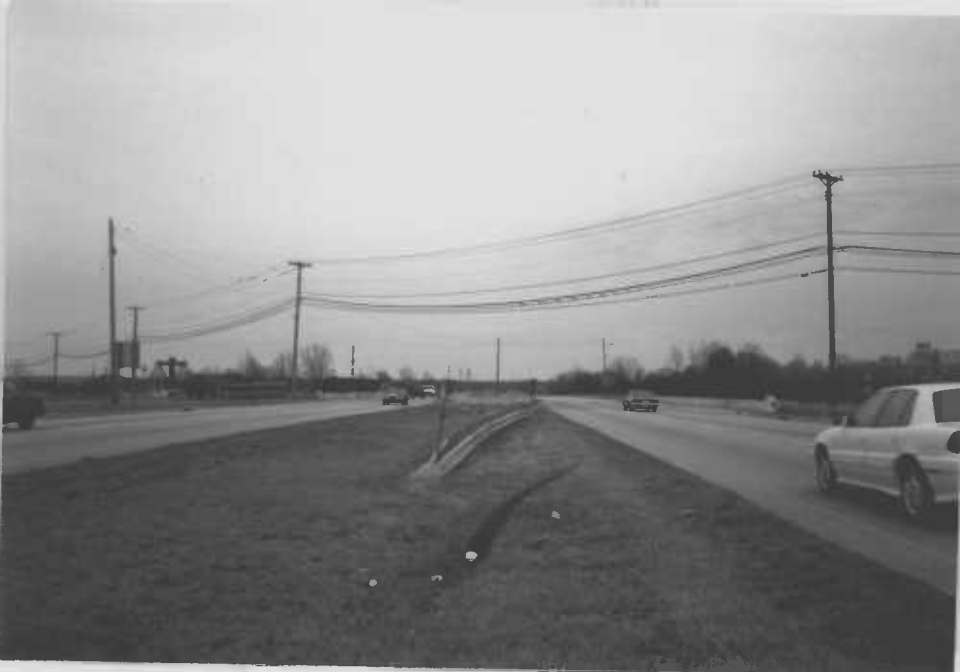
1. BA-2789
2. MD 151 OVER MD 150
3. Baltimore County
4. Eric Griffiths
5. 3/97
6. MD SHPO
7. east approach
8. 5 of 6

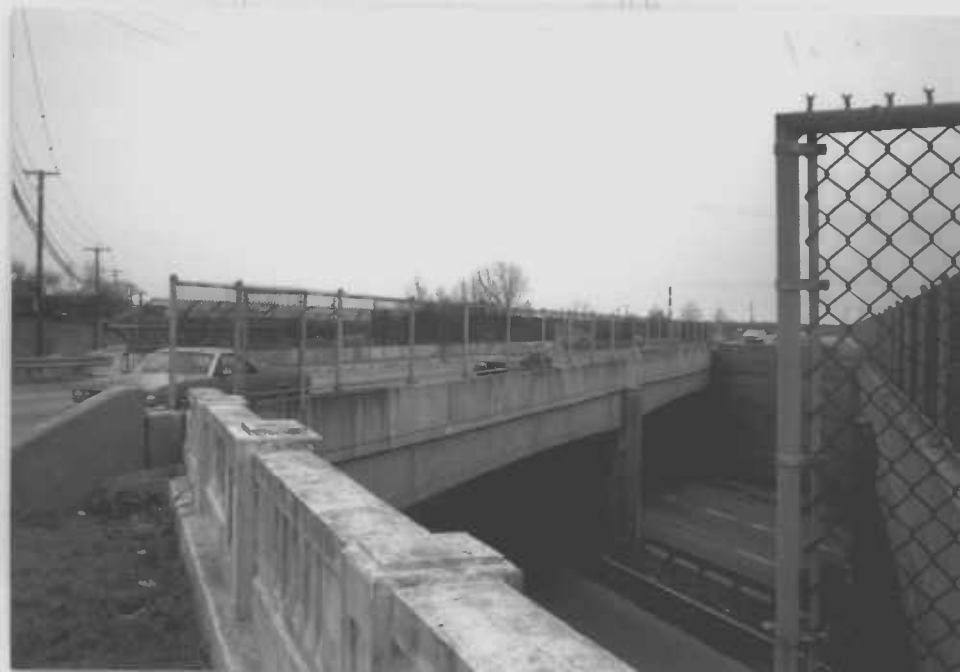
1. BA 2789
2. MB 151 over MB 150
3. Baltimore County
4. Eric Griffiths
5. 3/97
6. MD SHPD
7. south elevation of north bridge
8. 6 of 6
